# E6534.03-113-11-R1 ACOUSTICAL PERFORMANCE TEST REPORT ASTM E 90, ASTM E 492, ASTM E 2179

### SPECIALIZED SUPPLIES AND SERVICES, INC.

Series/Model: 25.4 mm SFR AcoustiTile

Specimen Type: Concrete Slab - 152 mm

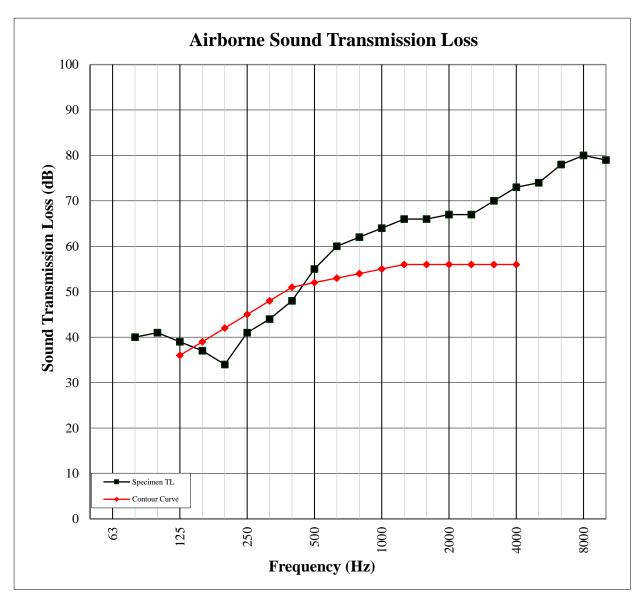
# AIRBORNE SOUND TRANSMISSION LOSS ASTM E 90

STC Rating 52 (Sound Transmission Class)

<b>Test Date</b>	03/25/15	
Data File No.	E6534.01	
Client	ECORE International	
Description	25.4 mm SFR AcoustiTile Rubber Tile Flooring, 152 mm Concrete Slab	
Specimen Area	10.98 m²	
Technician	Jordan Strybos

Emag	Background	Absorption	Source	Receive	Specimen	95%	Number
Freq	SPL	Absorption	SPL	SPL	TL	Confidence	of
(Hz)	(dB)	(m²)	(dB)	(dB)	(dB)	Limit	Deficiencies
80	53.6	16.3	107	67	40	4.30	-
100	41.3	14.8	107	66	41	2.30	-
125	37.1	10.6	106	68	39	1.20	0
160	32.7	11.0	107	71	37	1.40	2
200	29.4	11.9	104	70	34	1.90	8
250	26.8	11.7	104	62	41	1.40	4
315	24.7	10.6	103	59	44	0.40	4
400	21.8	9.1	102	55	48	0.70	3
500	23.9	8.2	103	49	55	0.50	0
630	23.9	7.9	104	47	60	0.60	0
800	24.1	7.9	104	44	62	0.60	0
1000	24.5	7.9	103	41	64	0.50	0
1250	25.9	7.9	104	41	66	0.80	0
1600	19.6	8.1	104	40	66	0.30	0
2000	12.7	9.3	103	38	67	0.50	0
2500	8.3	10.4	103	38	67	0.60	0
3150	6.4	11.8	103	33	70	0.60	0
4000	6.4	13.7	103	30	73	0.60	0
5000	5.8	16.9	103	27	74	0.70	-
6300	5.9	22.3	96	17	78	0.70	-
8000	6.2	29.9	96	12	80	1.00	-
10000	6.3	37.7	90	7	79	0.90	-

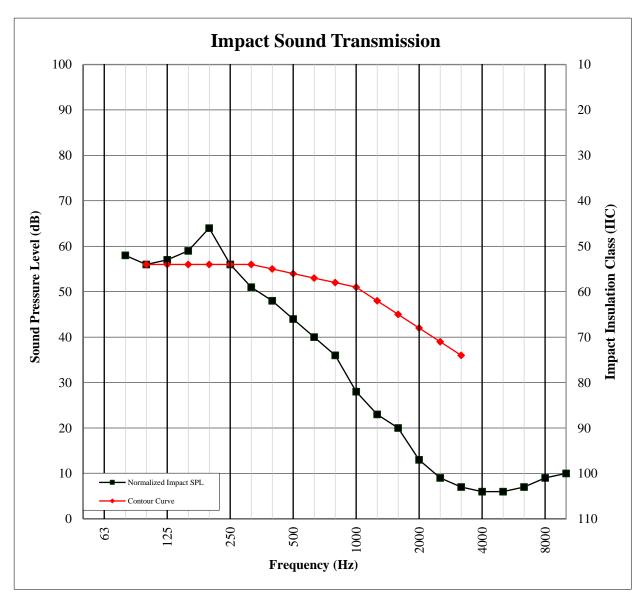
## IMPACT SOUND TRANSMISSION ASTM E 492

IIC Rating56(Impact Insulation Class)Deficiencies12(Sum of Deficiencies)

Test Date	03/25/15		
Data File No.	E6534.01		
Client	ECORE International		
Description	25.4 mm SFR AcoustiTile Rubber Tile Flooring, 152 mm Concrete Slab		
Specimen Area	10.98 m²		
Technician	Jordan Strybos

Freq	Background SPL	Absorption	Normalized Impact	95%	Number
ricq	Dackground St L	Absorption	SPL	Confidence	of
(Hz)	(dB)	$(m^2)$	(dB)	Limit	Deficiencies
80	50.9	17.8	58	2.9	-
100	43.7	13.5	56	1.5	0
125	40.8	10.3	57	1.5	1
160	33.4	10.3	59	2.2	3
200	28.1	12.7	64	2.3	8
250	26.5	11.8	56	0.7	0
315	24.2	10.1	51	1.1	0
400	21.6	9.4	48	0.5	0
500	25.1	8.3	44	1.3	0
630	24.4	7.8	40	0.6	0
800	24.9	8.0	36	0.8	0
1000	24.9	7.9	28	0.5	0
1250	23.5	8.0	23	0.4	0
1600	19.8	8.1	20	0.2	0
2000	12.5	9.2	13	0.3	0
2500	7.9	10.4	9	0.5	0
3150	6.2	11.8	7	0.2	0
4000	6.1	13.7	6	0.5	-
5000	5.6	17.1	6	0.5	-
6300	5.9	22.1	7	0.7	-
8000	6.2	30.1	9	0.9	-
10000	6.3	38.9	10	0.9	-

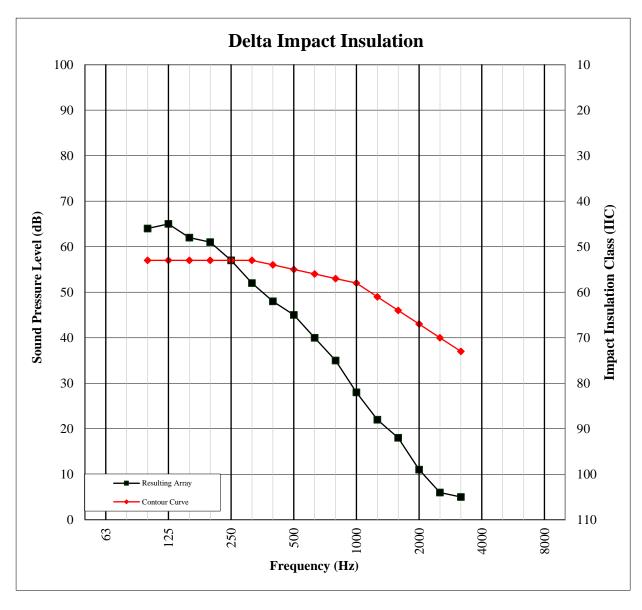
# DELTA IMPACT INSULATION

ΔIIC Rating 27 (Delta Impact Insulation Class)

Test Date	03/25/15
Data File No.	E6534.01
Client	ECORE International
Description	25.4 mm SFR AcoustiTile Rubber Tile Flooring, 152 mm Concrete Slab
Specimen Area	10.98 m²
Technician	Jordan Strybos

Euros	Bkgrd	Absorption	Normalized	95%	Normalized	95%	Resulting	No. of
Freq	SPL	(Square	Impact SPL	Conf	Impact SPL	Conf	Array	Defici-
(Hz)	(dB)	Meters)	BARE (dB)	Limit	SPEC (dB)	Limit	$L_{\text{ref,c}}$	encies
100	43.7	13.5	59.5	0.7	56.3	0.9	64	7
125	40.8	10.3	59.6	1.1	57.1	1.0	65	8
160	33.4	10.3	65.3	1.1	59.2	0.8	62	5
200	28.1	12.7	72.2	2.2	64.3	1.7	61	4
250	26.5	11.8	68.2	2.0	56.3	0.8	57	0
315	24.2	10.1	68.7	2.3	51.1	1.6	52	0
400	21.6	9.4	70.1	1.2	48.1	1.2	48	0
500	25.1	8.3	69.9	1.4	44.0	0.9	45	0
630	24.4	7.8	71.1	1.7	40.0	2.5	40	0
800	24.9	8.0	72.9	3.1	36.3	1.6	35	0
1000	24.9	7.9	72.6	1.3	28.2	0.5	28	0
1250	23.5	8.0	73.5	0.7	23.2	0.3	22	0
1600	19.8	8.1	73.8	1.5	19.6	1.2	18	0
2000	12.5	9.2	74.3	1.9	13.1	0.7	11	0
2500	7.9	10.4	74.8	1.3	9.1	0.6	6	0
3150	6.2	11.8	73.9	1.8	7.1	0.4	5	0

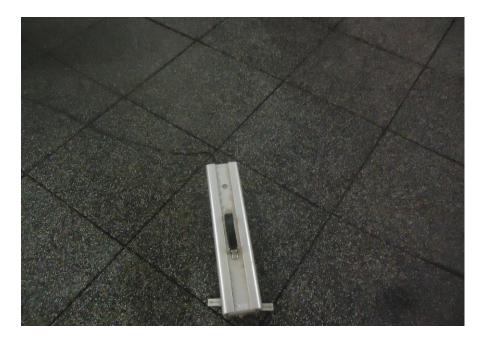
**Close-Up of Test Specimen**

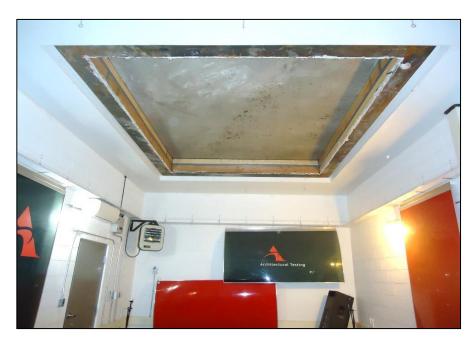
**Receive Room View of Test Specimen Installation**

Material	Dimensions (mm)	Thickness (mm)	Manufacturer and Series	Quantity	Average Weight
Rubber Tile Flooring	609.6 by 609.6	25.4	SFR AcoustiTile	10.98 m²	19.41 kg/m²
	Note: Loose laid				
Conomata Clah	3023 by 3632	152.0	N/A	10.98 m²	366.18 kg/m²
Concrete Slab	Note: The concret	e slab was inst	alled in a test frame flush to the source	room.
