D6771.09-113-11-R0
ACOUSTICAL PERFORMANCE TEST REPORT
ASTM E 90 AND ASTM E 492

SPECIALIZED SUPPLIES & SERVICES, INC.

Series/Model: SFR0002 Rubber Underlayment

Specimen Type: Floor/Ceiling Assembly

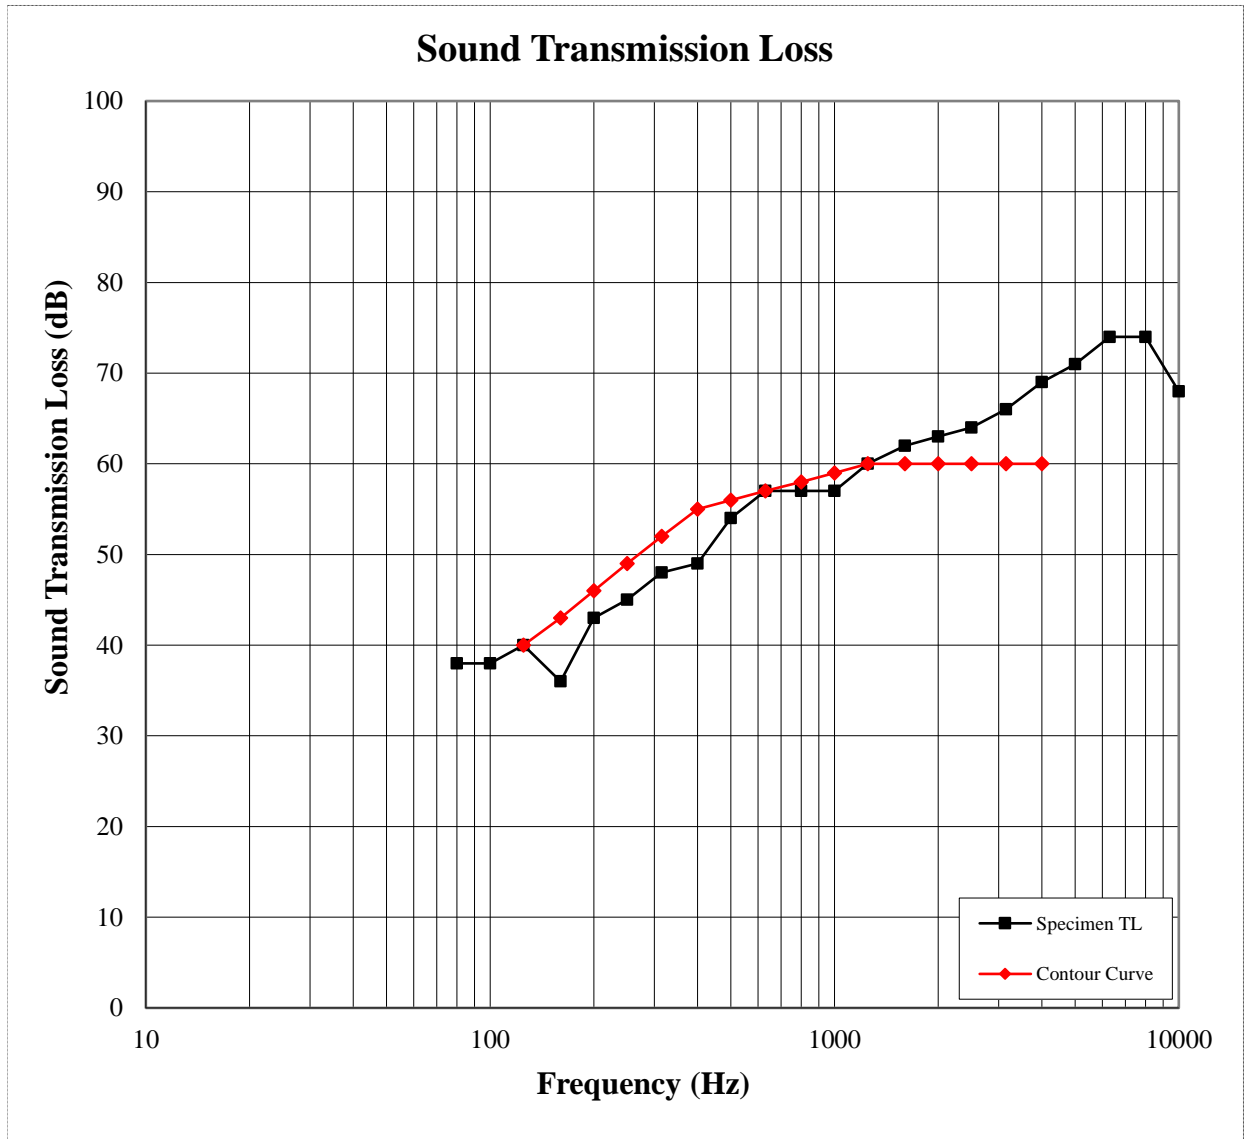
SOUND TRANSMISSION LOSS

Test Date	04/17/14
Data File No.	D6771.01A
Client	Specialized Supplies & Services, Inc.
Description	7.2 mm Porcelain Tile, 2 mm SFR0002 Rubber Underlayment, 203 mm Concrete Slab
Specimen Area	10.98 m ²
Technician	Daniel B. Mohler

STC Rating **56** *(Sound Transmission Class)*
Deficiencies **29** *(Sum of Deficiencies)*

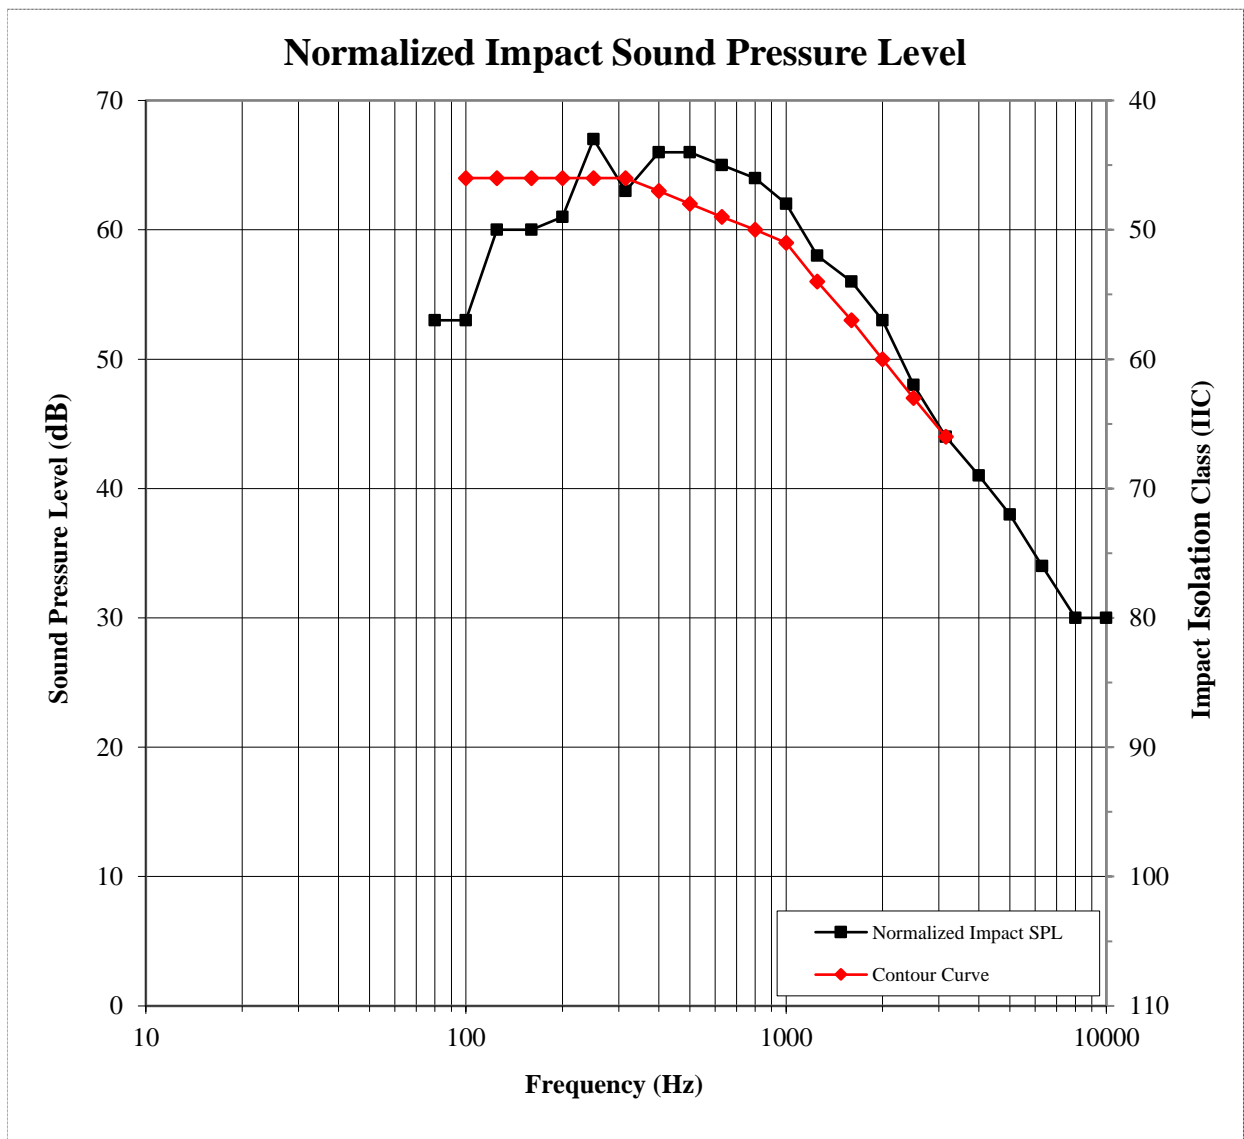
IMPACT TRANSMISSION

Test Date	04/17/14
Data File No.	D6771.01A
Client	Specialized Supplies & Services, Inc.
Description	7.2 mm Porcelain Tile, 2 mm SFR0002 Rubber Underlayment, 203 mm Concrete Slab
Specimen Area	10.98 m ²
Technician	Daniel B. Mohler

IIC Rating **48** *(Impact Insulation Class)*
Deficiencies **30** *(Sum of Deficiencies)*

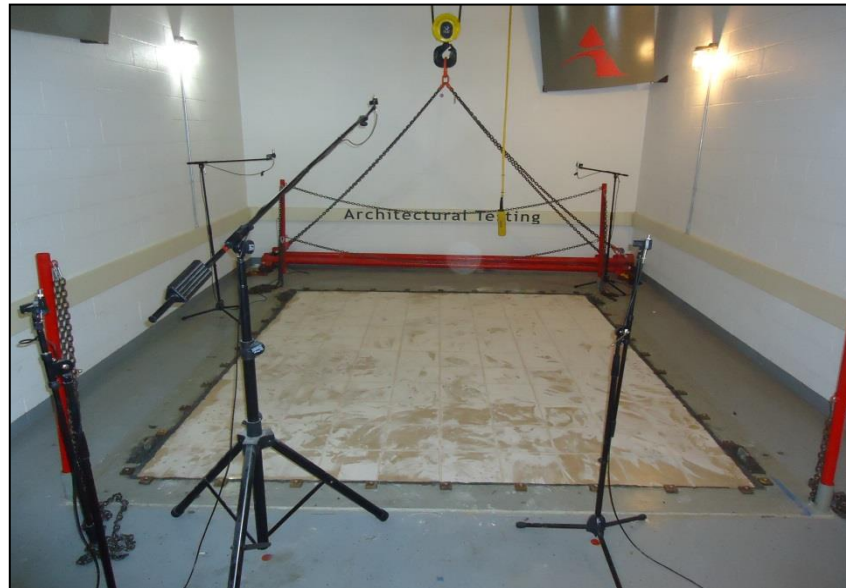
Source Room View of Test Specimen Installation

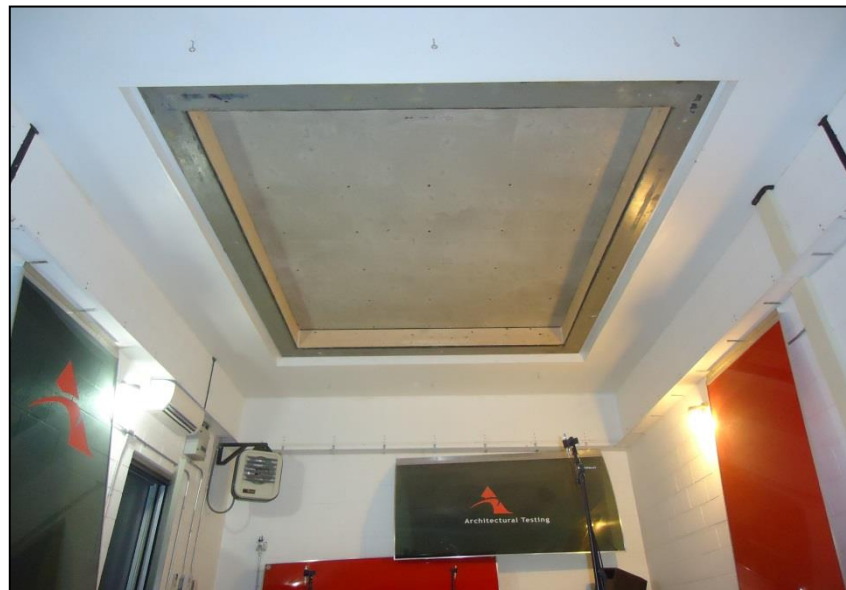
Receive Room View of Test Specimen Installation

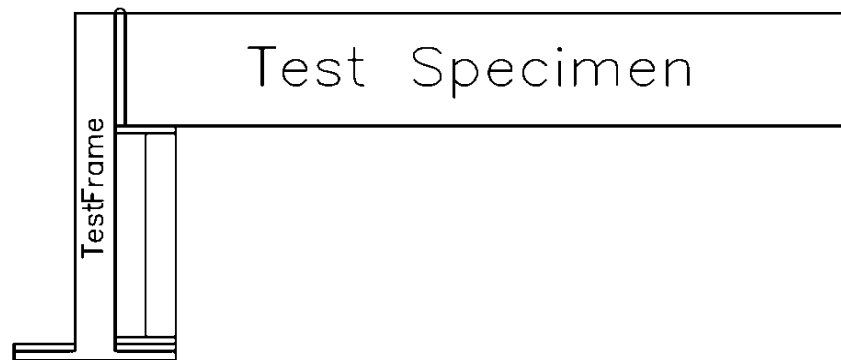
Test Specimen Installation

Cross Section View of Test Specimen

- 1 - Floor Topping
- 2 - Underlayment
- 3 - Concrete Slab

The porcelain tiles were set into the bed of mortar and separated by 6.35 mm spacers. Latex modified mortar was mixed as per manufacturer's specifications and troweled on top of the underlayment using a 9.53 mm by 9.53 mm square notch trowel. The mortar was allowed to cure according to the manufacturer's specifications. Sanded grout was mixed as per manufacturer's specifications and troweled into the 6.35 mm spaces between the ceramic tiles using a grout float. All excess grout was cleaned using a damp sponge. The grout was allowed to cure according to the manufacturer's specifications before testing. The perimeter of the porcelain tile floor was sealed to the test frame with duct seal.

A single layer of 2 mm SFR4002 was placed on top of the EGRIP EVOLVE flooring adhesive within 30 minutes of application. The EGRIP EVOLVE flooring adhesive was troweled over a protective layer using a 1.5 mm by 1.5 mm square notch trowel. A single layer of 0.05 mm polyethylene sheet was adhered to the concrete slab as a protective layer.

The concrete slab was installed into a test frame flush to the source room. The concrete slab was isolated from the test frame. The perimeter of the concrete slab was sealed with duct seal. Cure time for the concrete slab exceeded 28 days.
