D6771.11-113-11-R0
ACOUSTICAL PERFORMANCE TEST REPORT
ASTM E 90 AND ASTM E 492

Series/Model: SFR0010 Rubber Underlayment

Specimen Type: Floor/Ceiling Assembly

STC	57
IIC	53

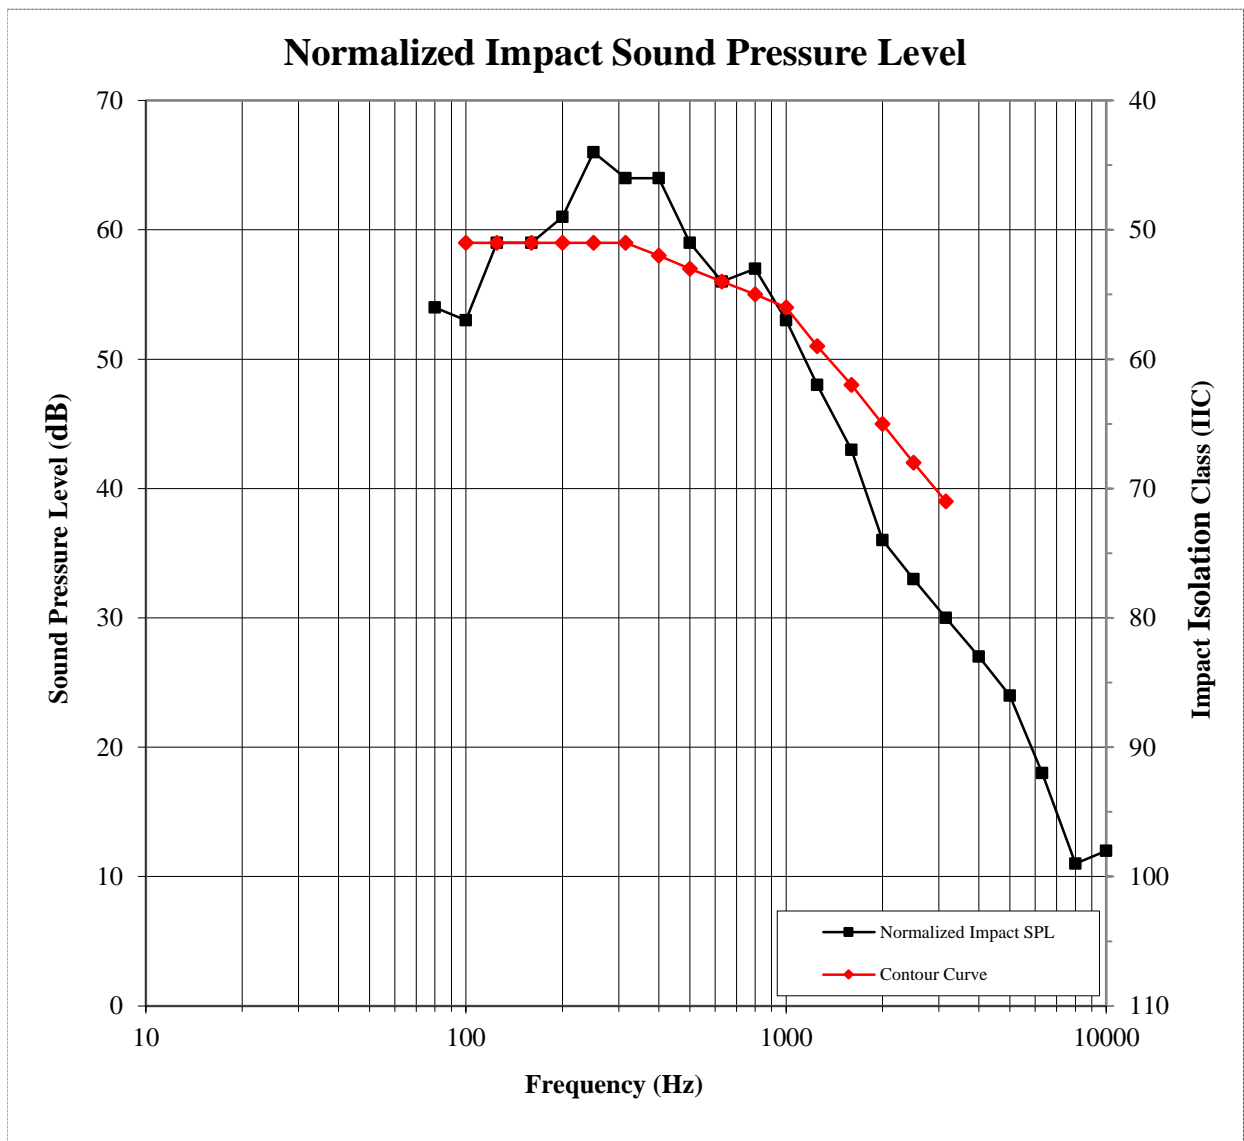
IMPACT TRANSMISSION
ASTM E 492

Test Date	05/01/14
Data File No.	D6771.03
Client	Specialized Supplies & Services, Inc.
Description	7.2 mm Porcelain Tile, 10 mm SFR0010 Rubber Underlayment, 203 mm Concrete Slab
Specimen Area	10.98 m ²
Technician	Daniel B. Mohler

Freq (Hz)	Background SPL (dB)	Absorption (m ²)	Normalized Impact SPL (dB)	95% Confidence Limit	Number of Deficiencies
80	51.4	16.1	54	15.5	-
100	42.7	11.3	53	3.3	0
125	36.3	8.8	59	1.1	0
160	27.8	8.9	59	3.4	0
200	23.3	11.1	61	2.1	2
250	23.7	9.9	66	1.0	7
315	19.9	9.3	64	1.8	5
400	19.7	8.1	64	1.2	6
500	20.9	6.9	59	3.8	2
630	18.9	7.0	56	3.3	0
800	20.7	7.1	57	1.6	2
1000	22.2	6.9	53	1.8	0
1250	21.5	7.1	48	2.1	0
1600	18.6	7.0	43	2.7	0
2000	12.8	7.9	36	4.9	0
2500	9.0	8.7	33	4.0	0
3150	7.3	9.5	30	4.7	0
4000	6.7	11.0	27	5.3	-
5000	6.6	12.9	24	5.0	-
6300	10.3	16.2	18	5.2	-
8000	9.0	21.5	11	1.8	-
10000	7.7	27.4	12	2.0	-

IIC Rating **53** *(Impact Insulation Class)*
Deficiencies **24** *(Sum of Deficiencies)*

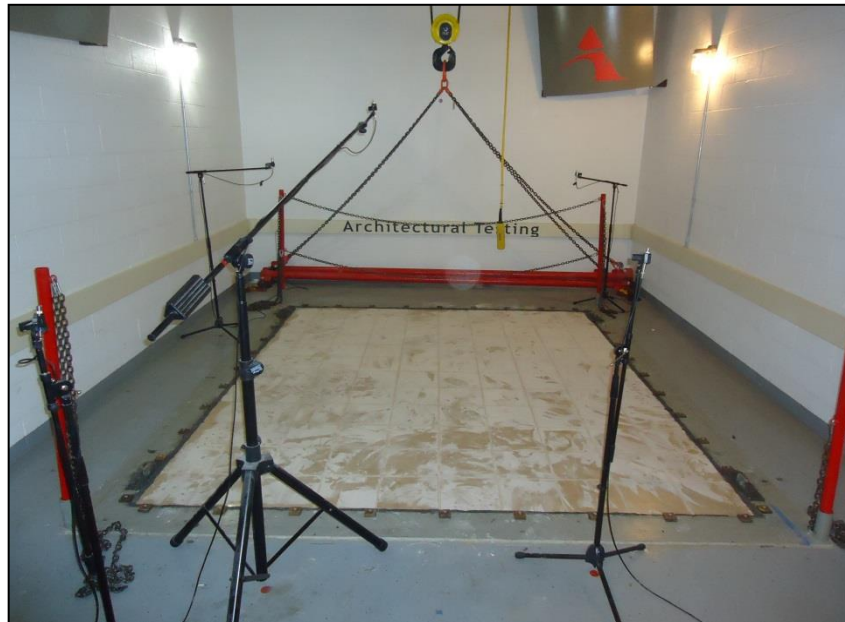
Source Room View of Test Specimen Installation

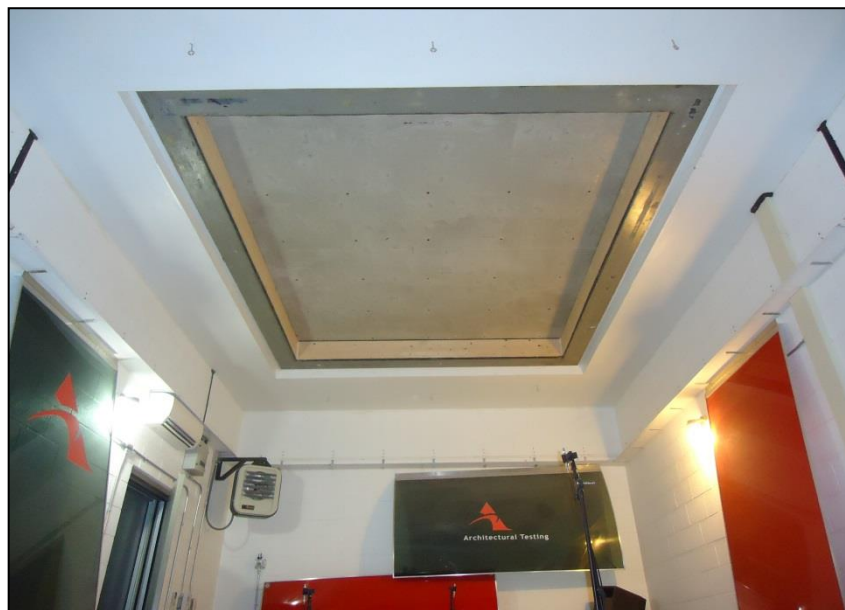
Receive Room View of Test Specimen Installation

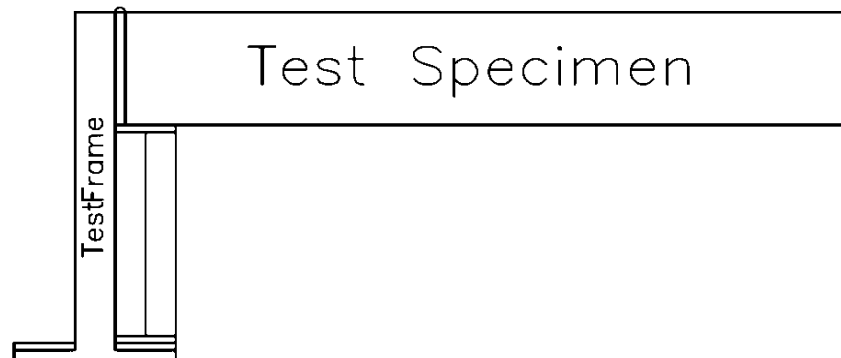
Test Specimen Installation

Cross Section View of Test Specimen

- 1 - Floor Topping
- 2 - Underlayment
- 3 - Concrete Slab

The porcelain tiles were set into the bed of mortar and separated by 6.35 mm spacers. The latex modified mortar was mixed as per manufacturer's specifications and troweled on top of the underlayment using a 9.53 mm by 9.53 mm square notch trowel. The mortar was allowed to cure according to the manufacturer's specifications. Sanded grout was mixed as per manufacturer's specifications and troweled into the 6.35 mm spaces between the ceramic tiles using a grout float. All excess grout was cleaned using a damp sponge. The grout was allowed to cure according to the manufacturer's specifications before testing. The perimeter of the porcelain tile floor was sealed to the test frame with duct seal.

A single layer of 10 mm SFR0010 was placed on top of the EGRIP EVOLVE flooring adhesive within 30 minutes of application. The EGRIP EVOLVE flooring adhesive was troweled over a protective layer using a 1.5 mm by 1.5 mm square notch trowel. A single layer of 0.05 mm polyethylene sheet was adhered to the concrete slab as a protective layer.

The concrete slab was installed into a test frame flush to the source room. The concrete slab was isolated from the test frame. The perimeter of the concrete slab was sealed with duct seal. Cure time for the concrete slab exceeded 28 days.
