D6771.12-113-11-R0
ACOUSTICAL PERFORMANCE TEST REPORT
ASTM E 90 AND ASTM E 492

Series/Model: SFR0012 Rubber Underlayment

Specimen Type: Floor/Ceiling Assembly

STC	57
IIC	53

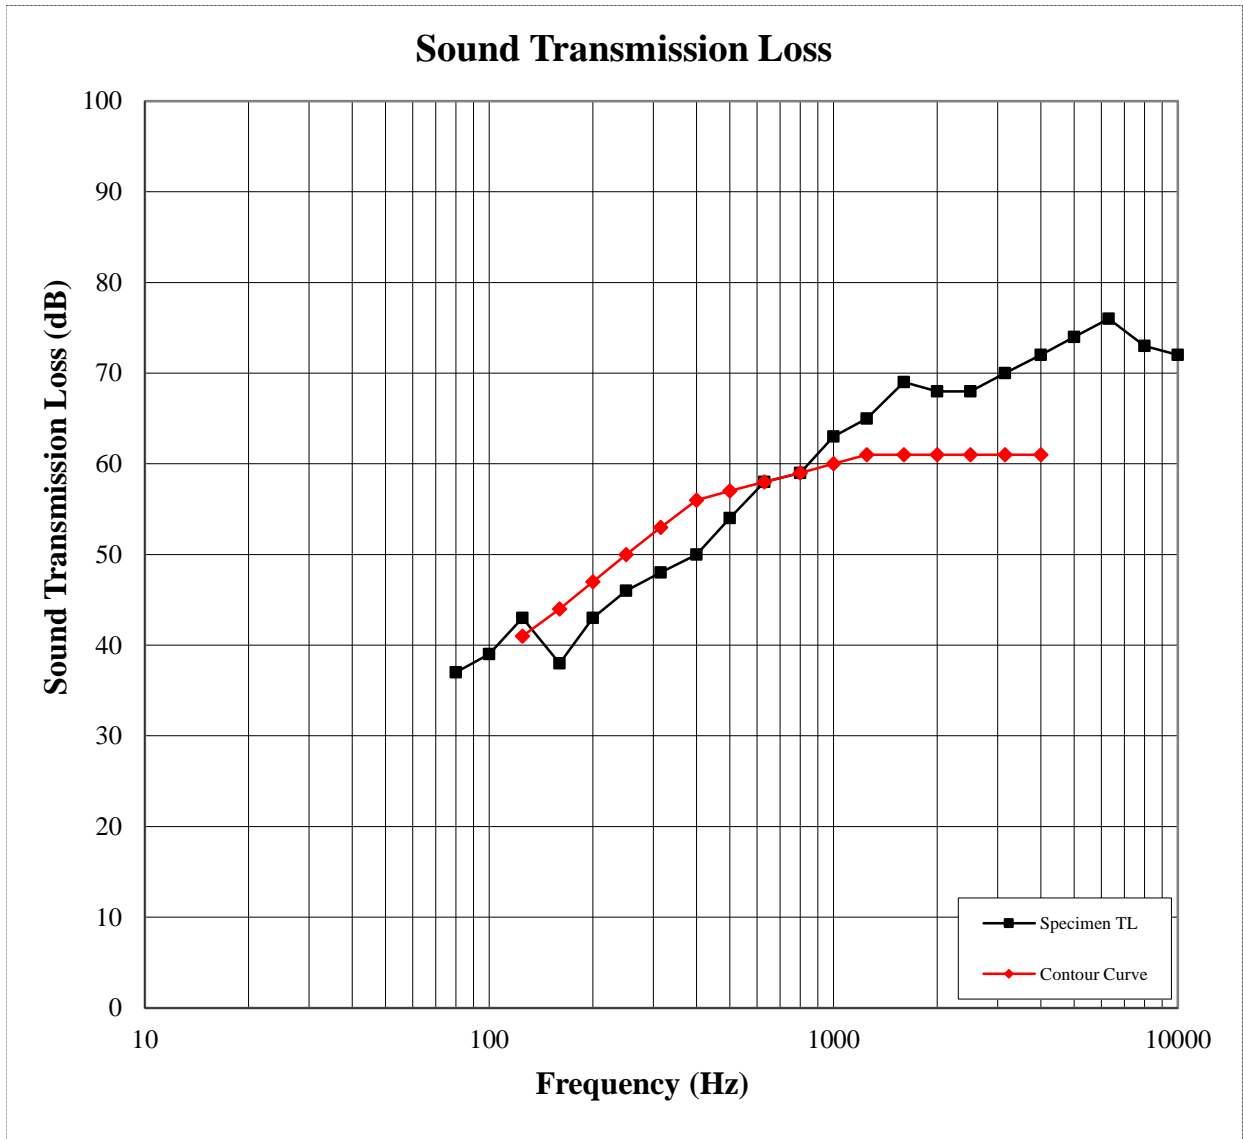
SOUND TRANSMISSION LOSS ASTM E 90

Test Date	04/25/14
Data File No.	D6771.04
Client	Specialized Supplies & Services, Inc.
Description	7.2 mm Porcelain Tile, 12 mm SFR0012 Rubber Underlayment, 203 mm Concrete Slab
Specimen Area	10.98 m ²
Technician	Daniel B. Mohler

Freq (Hz)	Background SPL (dB)	Absorption (m ²)	Source SPL (dB)	Receive SPL (dB)	Specimen TL (dB)	95% Confidence Limit	Number of Deficiencies
80	47.8	16.5	98	60	37	6.23	-
100	41.1	11.2	94	56	39	4.34	-
125	36.5	8.8	99	57	43	3.09	0
160	27.7	9.3	94	57	38	2.48	6
200	25.2	11.0	94	52	43	3.27	4
250	26.8	9.8	94	49	46	1.29	4
315	21.8	9.7	96	50	48	1.81	5
400	20.0	8.2	94	46	50	1.00	6
500	23.8	6.9	94	42	54	0.77	3
630	23.0	6.9	95	41	58	1.42	0
800	22.6	6.9	95	39	59	1.24	0
1000	22.5	6.9	96	36	63	0.89	0
1250	22.2	7.0	96	34	65	0.79	0
1600	22.8	7.1	94	29	69	0.90	0
2000	11.7	8.2	95	30	68	0.55	0
2500	10.0	9.4	94	27	68	0.64	0
3150	10.4	10.5	94	24	70	1.32	0
4000	9.6	12.9	93	21	72	1.51	0
5000	9.9	15.8	93	17	74	2.54	-
6300	10.5	20.5	91	14	76	4.91	-
8000	11.2	28.2	90	14	73	6.55	-
10000	11.8	36.2	91	15	72	7.31	-

STC Rating **57** (*Sound Transmission Class*)

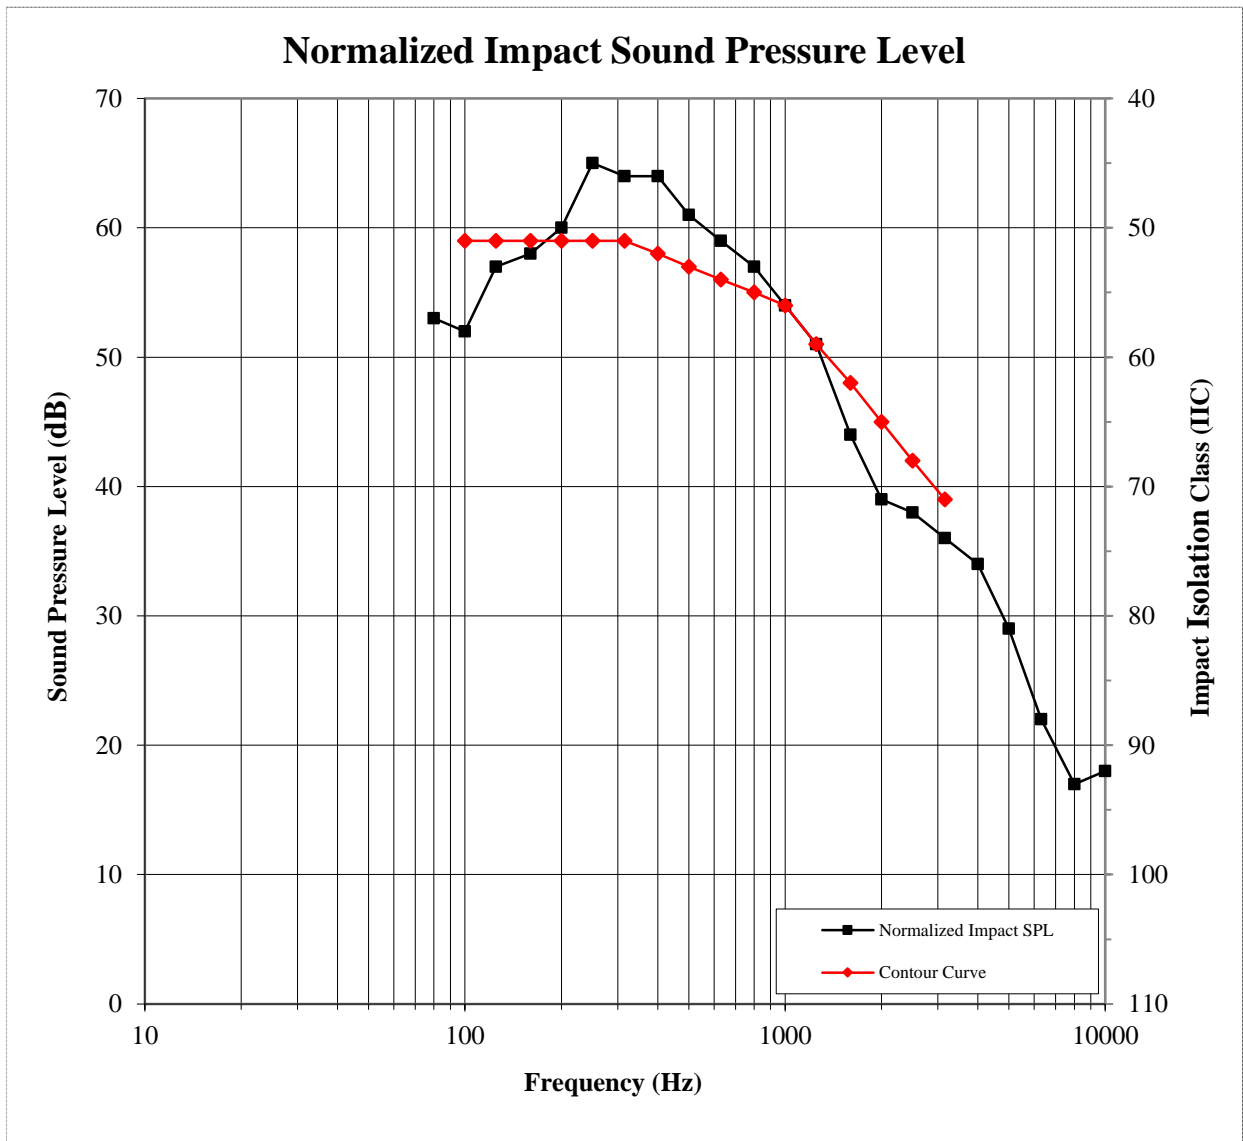
IMPACT TRANSMISSION ASTM E 492

Test Date	04/25/14
Data File No.	D6771.04
Client	Specialized Supplies & Services, Inc.
Description	7.2 mm Porcelain Tile, 12 mm SFR0012 Rubber Underlayment, 203 mm Concrete Slab
Specimen Area	10.98 m ²
Technician	Daniel B. Mohler

Freq (Hz)	Background SPL (dB)	Absorption (m ²)	Normalized Impact SPL (dB)	95% Confidence Limit	Number of Deficiencies
80	45.7	16.0	53	3.3	-
100	42.5	10.9	52	2.2	0
125	35.7	8.7	57	3.7	0
160	26.4	9.5	58	4.4	0
200	23.6	10.8	60	5.1	1
250	26.9	9.7	65	2.3	6
315	21.2	9.6	64	2.6	5
400	19.1	8.2	64	1.5	6
500	24.9	6.9	61	3.1	4
630	22.2	6.9	59	1.5	3
800	21.5	6.9	57	2.3	2
1000	22.7	7.0	54	1.5	0
1250	19.5	7.0	51	3.6	0
1600	16.1	7.2	44	5.1	0
2000	9.3	8.3	39	4.1	0
2500	7.0	9.3	38	2.5	0
3150	5.3	10.4	36	1.4	0
4000	5.4	12.9	34	1.7	-
5000	5.9	15.6	29	3.1	-
6300	6.3	20.2	22	8.0	-
8000	6.8	27.9	17	13.0	-
10000	7.1	35.6	18	13.2	-

IIC Rating **53** *(Impact Insulation Class)*

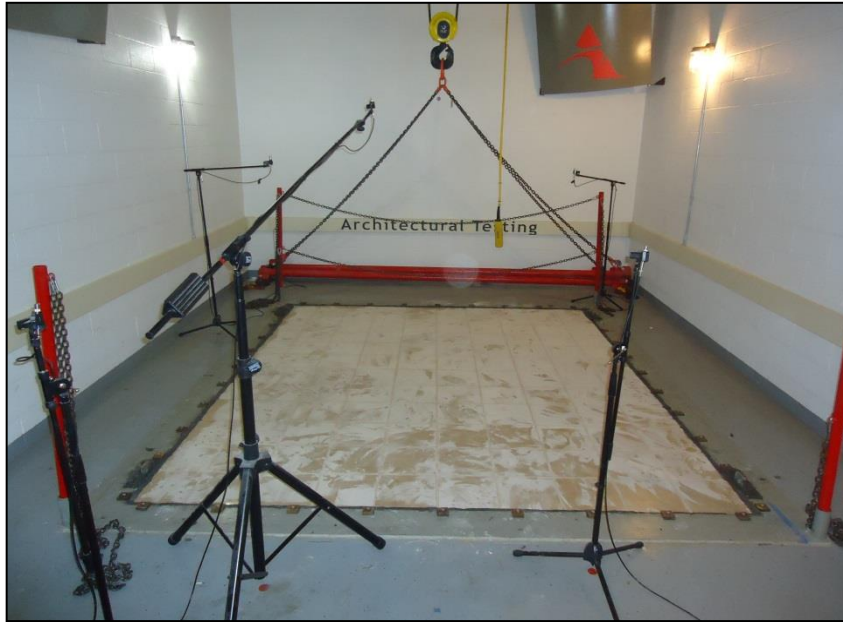
Source Room View of Test Specimen Installation

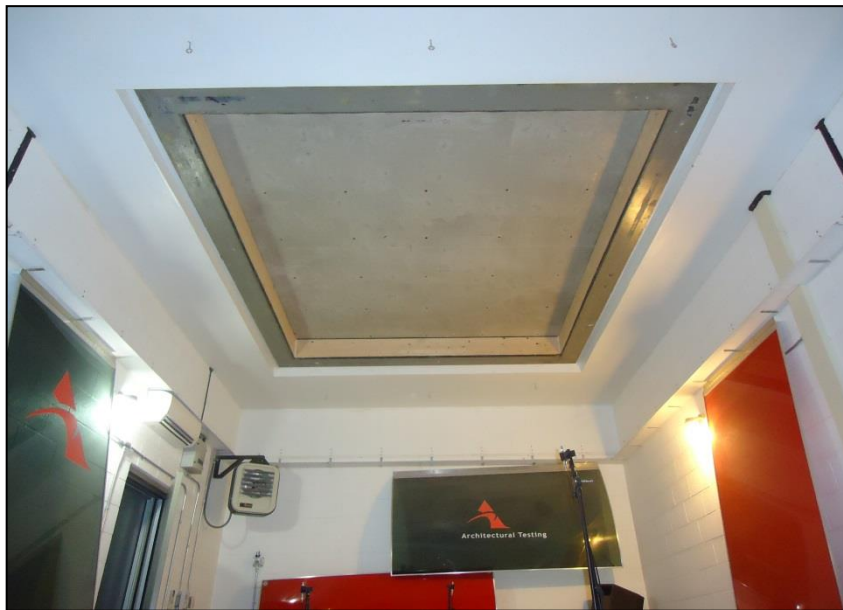
Receive Room View of Test Specimen Installation

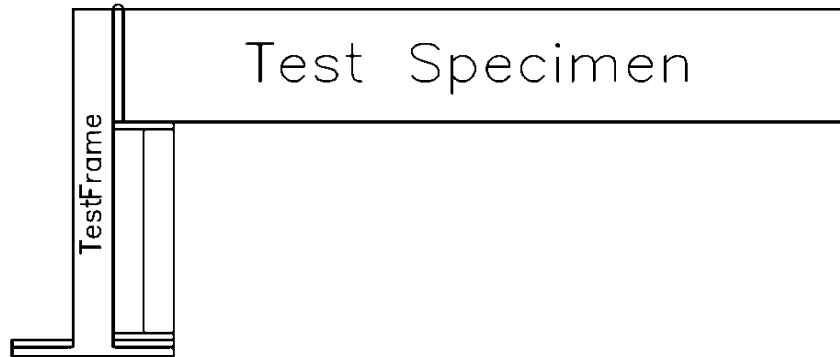
Test Specimen Installation

Cross Section View of Test Specimen

- 1 - Floor Topping
- 2 - Underlayment
- 3 - Concrete Slab

The porcelain tiles were set into the bed of mortar and separated by 6.35 mm spacers. Latex modified mortar was mixed as per manufacturer's specifications and troweled on top of the underlayment using a 9.53 mm by 9.53 mm square notch trowel. The mortar was allowed to cure according to the manufacturer's specifications. Sanded grout was mixed as per manufacturer's specifications and troweled into the 6.35 mm spaces between the ceramic tiles using a grout float. All excess grout was cleaned using a damp sponge. The grout was allowed to cure according to the manufacturer's specifications before testing. The perimeter of the porcelain tile floor was sealed to the test frame with duct seal.

A single layer of 12 mm SFR0012 was placed on top of the EGRIP EVOLVE flooring adhesive within 30 minutes of application. The EGRIP EVOLVE flooring adhesive was troweled over a protective layer using a 1.5 mm by 1.5 mm square notch trowel. A single layer of 0.05 mm polyethylene sheet was adhered to the concrete slab as a protective layer.

The concrete slab was installed into a test frame flush to the source room. The concrete slab was isolated from the test frame. The perimeter of the concrete slab was sealed with duct seal. Cure time for the concrete slab exceeded 28 days.
